KELSALE

Conservation Area Appraisal

Supplementary Planning Document

November 2018

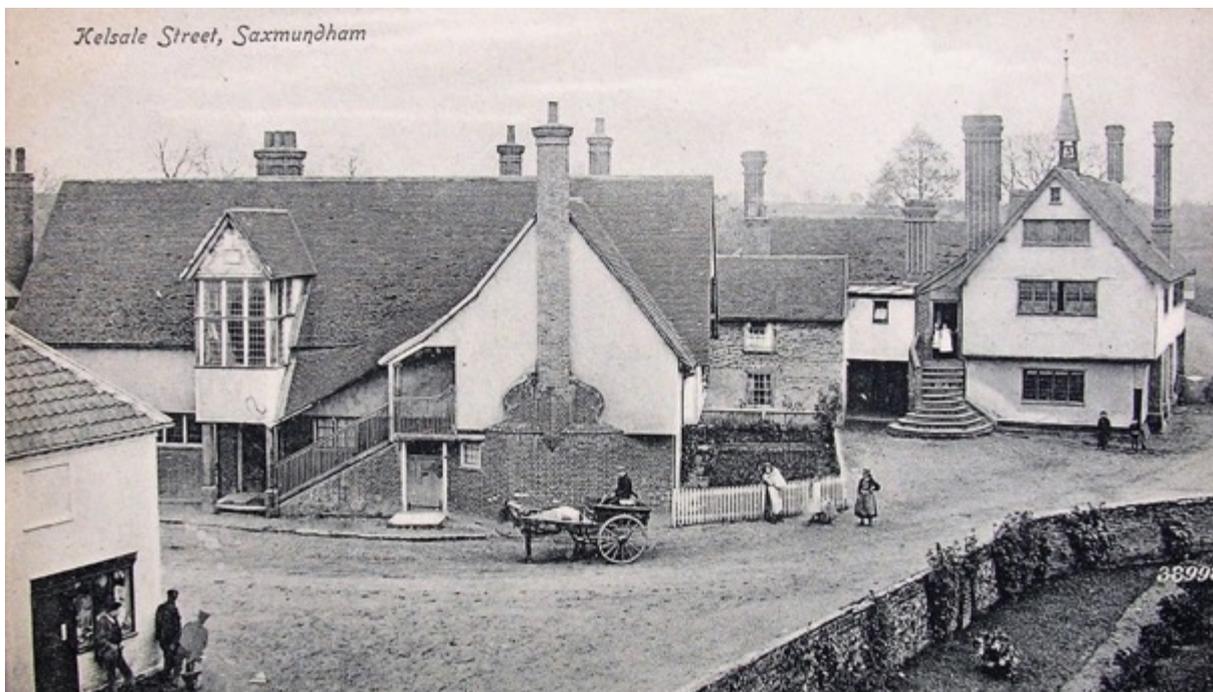
Kelsale Social Club, The Old Guildhall and Corner Cottage c1910. Richard Norman Shaw's bellcote on the Guildhall roof has since been removed and the porch of the Social Club has lost some of its pargetted decoration

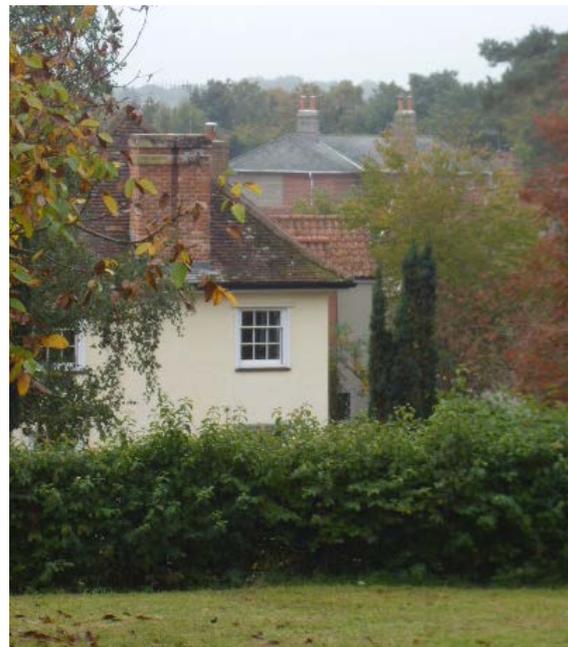
Red brick, render, plain tiles, pantiles, white brick and slate can all be seen in this one view over the village

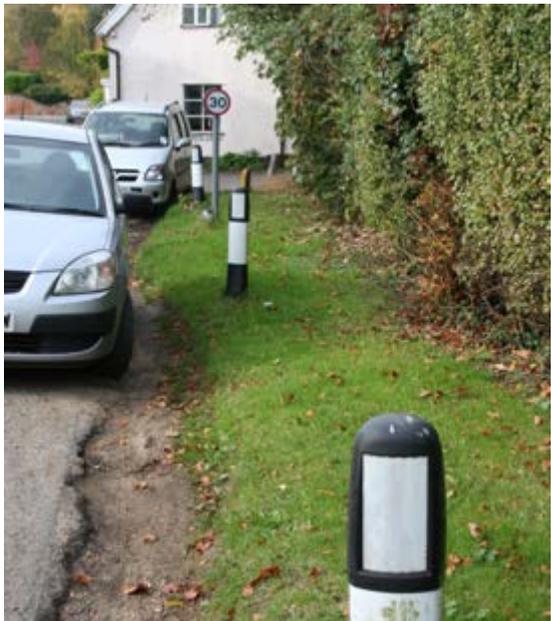
Plastic bollards, verge erosion and speed restriction signage

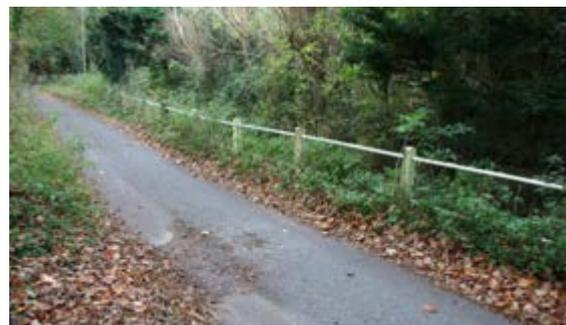
Concrete posts and iron guard rail on Tiggins Lane, providing a safety barrier between the road and stream

Other railings, of mid twentieth century date, have a more utilitarian appearance but usefully guard the public from a ditch or watercourse. The retention and maintenance of these low-key features is important on safety grounds. While not intrinsically of historic merit, if replaced any future item should adopt the low-key appearance and simplicity of design as the extant items.

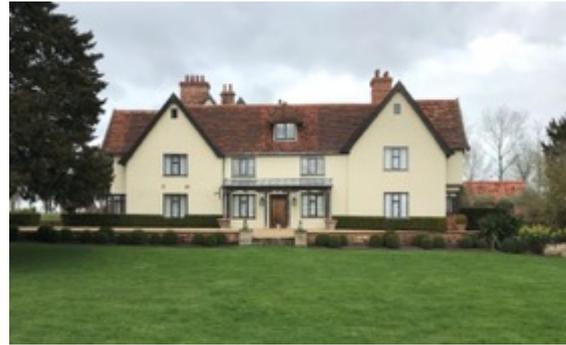
South Front of The Old Manor House

Old Manor House, Bridge Street (Grade II) A substantial detached house standing close to the parish church, on a site which also contains a late medieval drainage moat. The house is set back a considerable distance from the road upon the crest of a gently sloping hill. Fragments of thirteenth and fourteenth century pottery were found here during excavations in 2009.

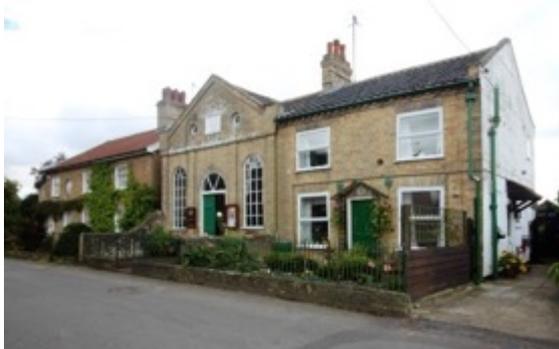
Chapel Cottage and The Methodist Chapel, Bridge Street

Chapel Cottage, Bridge Street A two storey cottage faced in gault brick with a dentilled eaves cornice which is attached to the chapel's western wall. It was originally built as the manse to the adjoining chapel and probably dates from c1851. The window joinery was replaced in the late twentieth century but original openings with wedged-shaped lintels are preserved. Central, nineteenth century four panelled door beneath a wedge-shaped lintel. Late twentieth century trellised wooden porch. Pan tile roof and gault brick stack to the eastern gable. The western gabled return elevation is now painted.

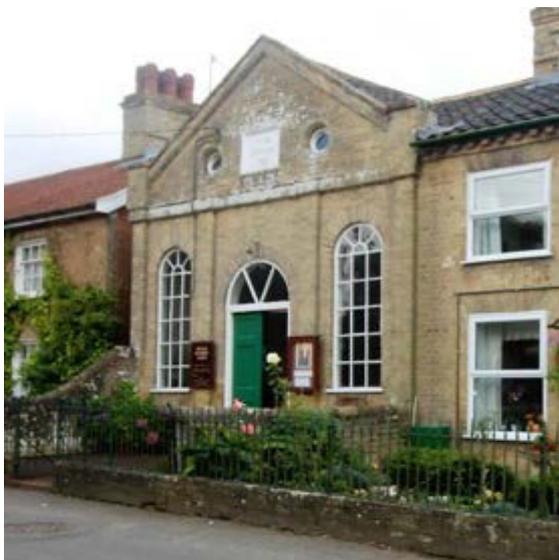
Methodist Chapel, Bridge Street

Central arched doorway with a replaced radial fanlight and two centrally opening three panelled doors. The original radial fanlight was of a far more elaborate design. The doorway is flanked by tall arched small pane casement windows. Each bay of the façade is separated by pilasters and there is a central date stone above the doorway flanked to each side by an oculus.

The circular window at first floor level appears on Edwardian photographs of the building. Single storey lean-to with red pan tile roof to western end with decorative parapet to Brook Street elevation. Replacement railings to boundary with Bridge Street. Late twentieth century garage block to east.

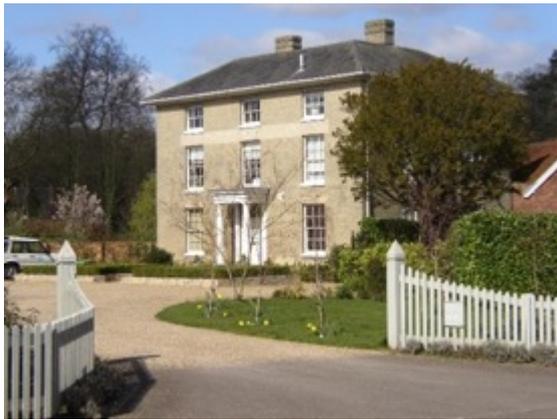
Bell House, Church Lane

Bell House, Church Lane (grade II) A distinguished classical building of early to mid-nineteenth century date with a sixteenth-seventeenth century wing to the rear facing Church Lane. It forms part of a memorable group with Rectory Cottages and is prominently located. Formerly a public house, it is shown as the Eight Bells Inn on the 1884 1: 2,500 Ordnance Survey map. It is also recorded as a public house in White's 1855 Directory. The pub closed in 1987 and is now a dwelling. The columned porch is a late twentieth century replacement for the heavy late nineteenth century hood on ornamental cast iron brackets which is recorded in the listing description. This late nineteenth century porch had itself replaced an earlier portico.

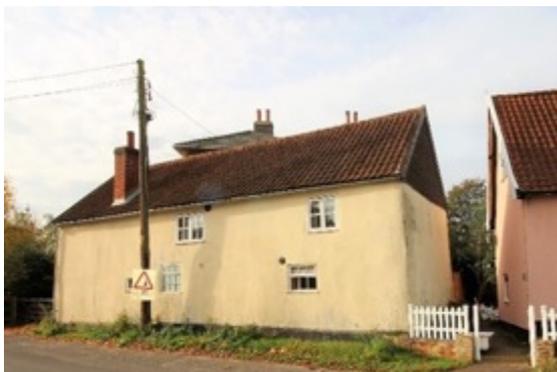
The sixteenth century rear range of Bell House

A timber framed and pan tiled outbuilding to the rear was renovated c.1980 and incorporated into the main building. At the Church Lane and Bridge Street corner is a prominently located red brick and cobble boundary wall of probably early nineteenth century date, which forms an important part of the setting of the grade II listed structure. The adjoining wooden gate piers and picket fence are of late twentieth century date. Further weatherboarded outbuilding with a replaced red pan tile roof to rear. Bettley, J, and Pevsner, N, *The Buildings of England, Suffolk: East* (London, 2015) p381.

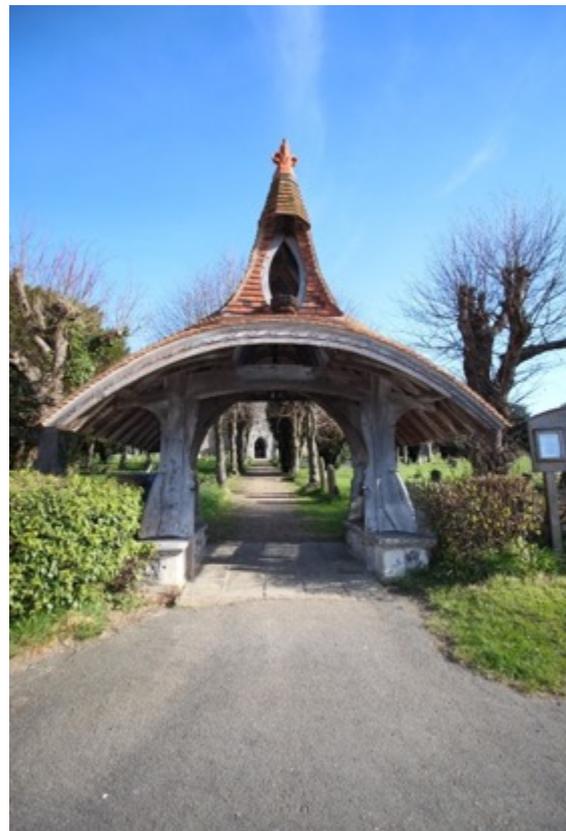
Lych Gate to Saint Mary and Saint Peter's Church

S. Prior for the then rector The Reverend George Irving Davies as a memorial to his wife. Timber framed on a stone and flint plinth, plain tiled roof. The uprights each side of the entrance have buttresses carved in the manner of medieval crown posts; shallow arched tie beam carved with the words 'Come unto me ye weary and I will give you rest'. The roof has a sweeping curve over the entrance front with a tall pointed section enclosing a niche which is now empty; carved fascia board; the rear of the roof is half hipped.

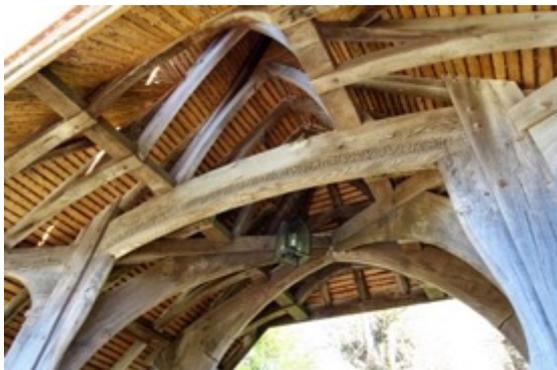
Roof structure of the Lych Gate to Saint Mary and Saint Peter's Church

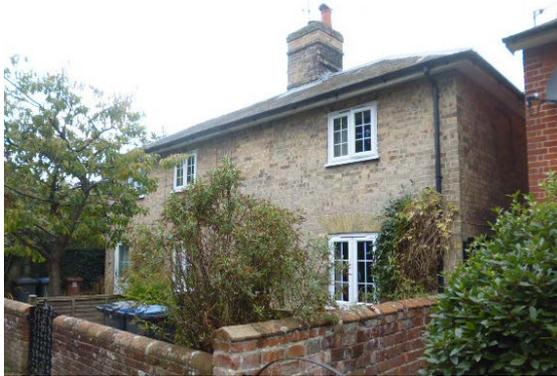
Nos. 1 & 2 Denny's Lane

Adams Cottage No. 1 & No.2 Denny's Lane and boundary wall to front. A semi-detached, early to mid-nineteenth century pair of cottages with a gault brick faced façade to Denny's Lane. Shallow pitched Welsh slate roof. Denny's Lane façade has replaced casement windows within original openings and wedge-shaped gault brick lintels to the openings. Both houses have replaced, partially glazed front doors. Adams Cottage with single storey late twentieth century conservatory addition. Red brick garden wall to Denny's Lane possibly of later nineteenth century date.

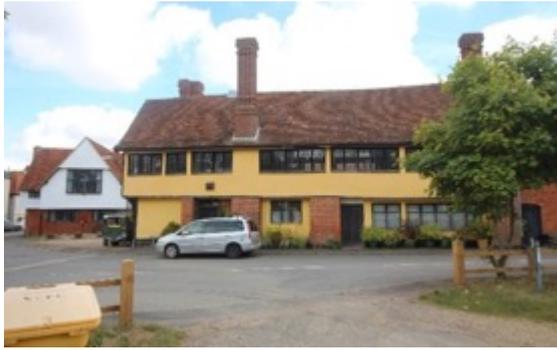
The Old Guildhall from the west

The Old Guildhall was restored and converted to the village school 1868-1870 to the designs of Richard Norman Shaw. The contractors were Thomas Denny and William Kerridge of Kelsale. Shaw also added a tall wooden bellcote which has since been removed. His external stair has also been replaced. It is linked to the village club by an eighteenth century structure the sash windows of which have been replaced and the openings altered.

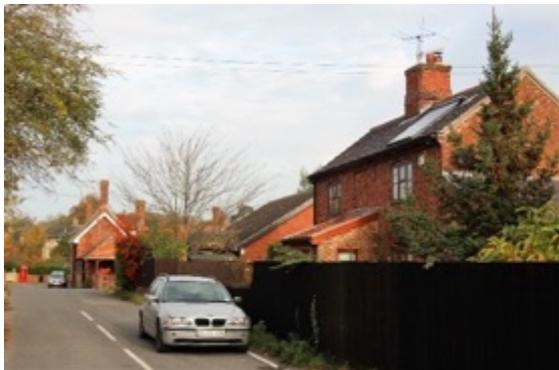
Walnut Tree House, Low Road

Walnut Tree House, Low Road A detached two storey red brick cottage of early to mid-nineteenth century date with a black pan tile roof and a dentilled brick eaves cornice. Substantial central red brick ridge stack with rebuilt upper section. It has a symmetrical three-bay façade to Low Road, with a centrally placed early twenty-first century red brick lean-to porch with a red pan tile roof. Above the porch is an original blind recess with a stone sill. The casement windows within this façade are c2000 replacements.

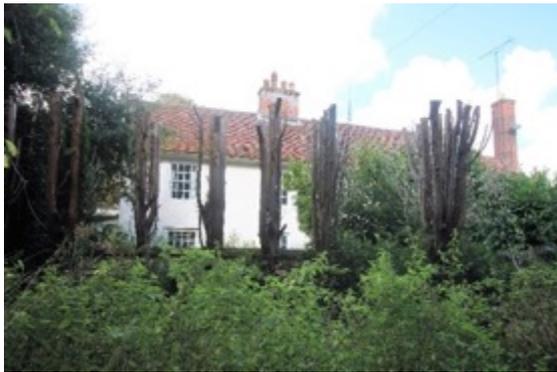
Kelsale Manor from Tiggin's Lane

Kelsale Manor, Tiggin's Lane (grade II*) A substantial timber framed farmhouse with an early sixteenth century (or possibly earlier) core, and early eighteenth century rendered façades. Formerly called Manor Farm, in the nineteenth century it belonged to the Bence Lambert family of Thorington Hall but in the mid eighteenth century it was the property of the wealthy Ketts. In the early 1920s a door knocker with the Kett crest was noted at the house. In 1921 LM Kett described the house as *"an Elizabethan house with two wings and an old oak staircase, panelled rooms, quaint chimneys and fireplaces. The windows of the drawing room have nice bevelled glass."*

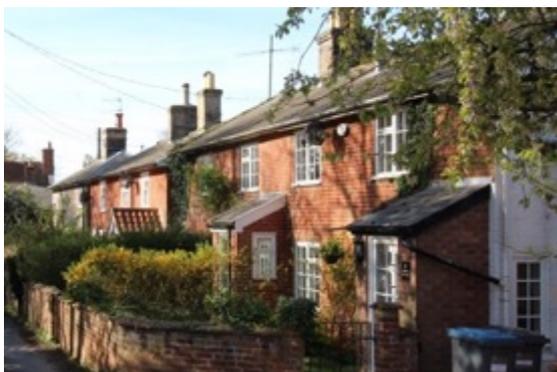
Altered nineteenth century cottages on Denny's Lane

Other undesirable changes can include alterations and extensions which do not respect the scale, form, and detailing of existing buildings, the use of modern materials and details, insensitive highway works and signage, unsympathetic advertising and the construction of intrusive walls, balustrades, fences, driveways, garages, and other structures. The use of concrete tiles, artificial slates, uPVC and aluminium windows and doors, cement render and modern bricks should all be avoided. So too should the use of brown stain on timber joinery as it invariably appears as a discordant feature.

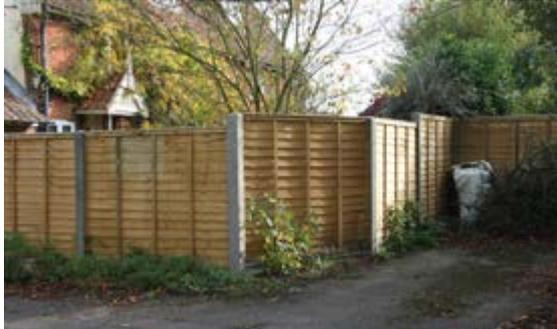
The negative visual impact of fence panels and concrete posts

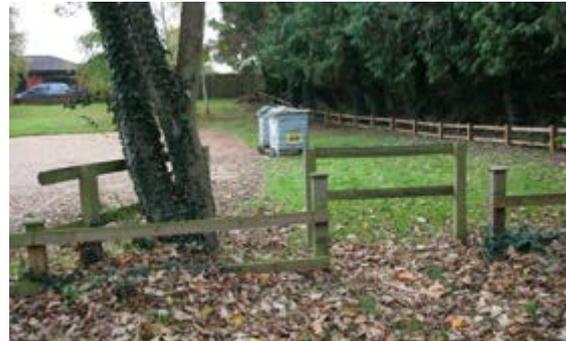
The importance of grass verges, vegetation and the loose chipping surface to the car park. The positioning of bins and street furniture needs further consideration
